The Nuclear Hazards of the Recovery of the Nuclear Powered Submarine *Kursk*

Peter Davidson *Principal Safety Consultant, NNC Ltd*
Huw Jones *Commander, Royal Navy*
John H Large *Large & Associates, Consulting Engineers*

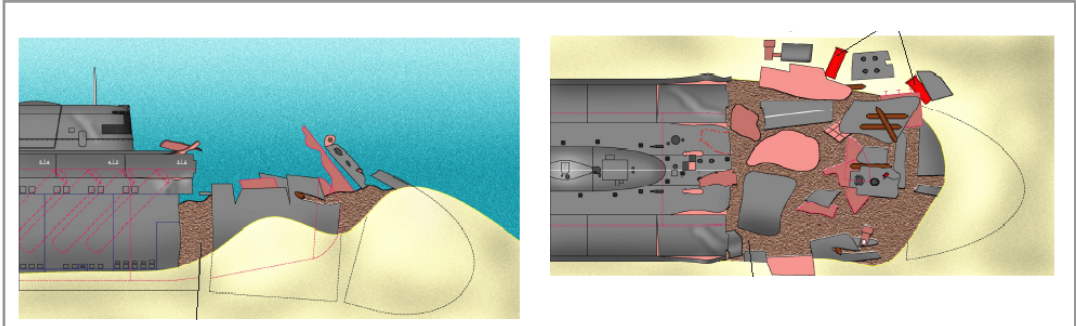
The bow damage showing failure of both flood and pressure hulls- internally the damage extended into the boat, collapsing lateral bulkheads into through to N° 5 Compartment- the red cylinders are gas bottles

It is clear from the sonar records of the very much larger second explosion that this was from five to seven individual events occupying, in all, just over one-fifth of a second. This multi-explosion, equivalent to 2 to 3 tonnes of TNT, is believed to have derived from the detonation of up to 7 fully armed torpedo rounds in the forward port magazine rack. This massive explosion, inside the pressure hull, dealt a catastrophic blow to the *Kursk*, ripping out a very large section of the forward pressure hull (10 x 8m area) and outer casing and, at the same time, sending a reverberating hammer blow through the compartments towards the stern. Structural and flood bulkheads N° 2 and 3 were ripped through, with N° 4 buckling and

subsequently collapsing under the hydrostatic flood loading. N° 5, the forward reactor compartment bulkhead, and the remaining bulkheads through to the ninth compartment remained intact.

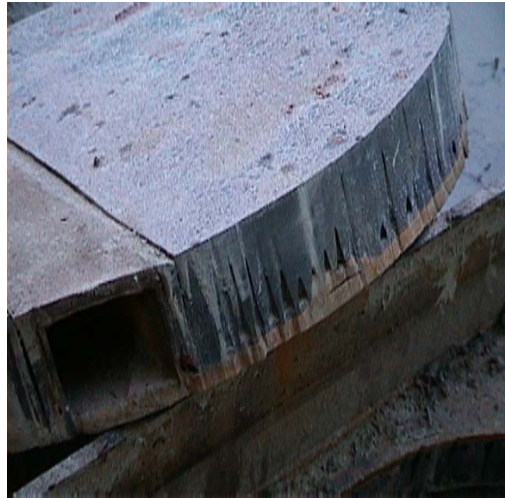
The External Acoustic Layer, showing Noise/Sonar Attenuation Voids revealed by the cutting of the lifting sockets

Designed by RUBIN, The Russian State Marine Engineering Design Bureau in St Petersburg, the *Kursk* was 154 m long and 18m beam over the casing or flood hull, with a 11m diameter internal pressure hull, and of submerged displacement 24,000 tons (surface 11,500t). The submarine structure was of double hull construction with nine interconnected watertight compartments, all being normally accessible except for the reactor compartment N° 6 which is passed through via a radiation shield corridor. The outer hull casing comprised 8mm steel plates supported off the pressure hull by webs and struts. The inner pressure hull was an externally ribbed cylindrical form fabricated from 50mm thick high yield steel plate. The void between the casing and pressure hull varied from 1 to 4m within which was located ship's equipment, sonar and the cruise missile silos. The entire outer hull and conning tower was clad with 40 to 80mm thick synthetic rubber tiles serving to both attenuate machinery noise and reduce the reflective echo from incoming sonar signals.

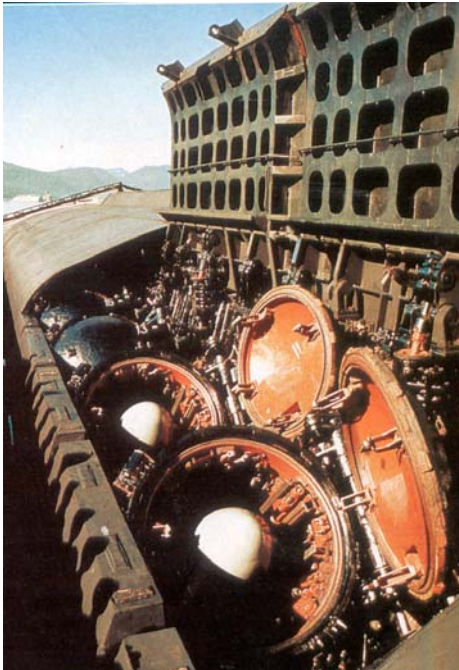
*Starboard Missile Bank
Forward Silo Hatches Open*

The *Kursk* submarine had an armament capacity for 24 ship-to-ship cruise missiles (SN-19-GRANIT - NATO Shipwreck) armed with 760kg main charge conventional explosive but nuclear capable for low yield warheads. The missiles were housed in individual pressure sealed silos, pitched

forward at 40° arranged in two rows of twelve, each covered by six hatches on each side of the sail (conning tower).

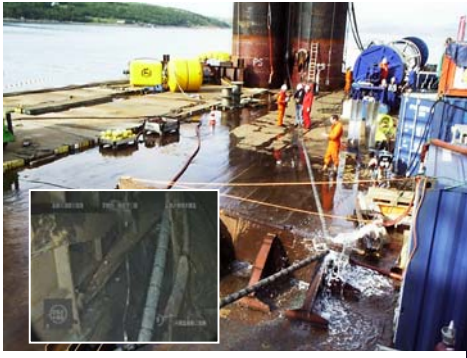
The cable cutting rig trials on Giant 4 suction anchors (top) acting against an opposite set actual underwater cutting (inset)

Severing the remains of N° 1 compartment deployed a heavy cable carrying thick-walled tubular sections coated with a very coarse (~25mm) abrasive. Reciprocating

motion was to be provided by two 30 tonne hydraulic rams attached by suction anchors to the seabed.

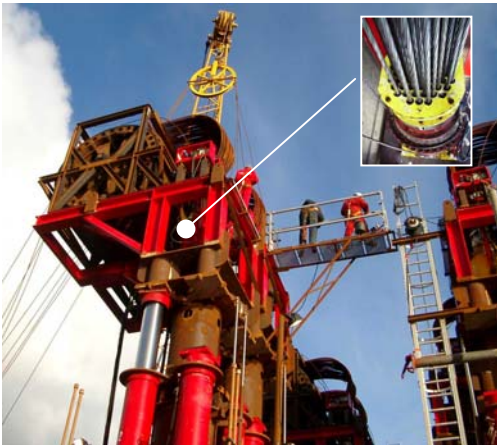
The strand jack (inset) mounted within the cable reel platform with the swell compensator rams underneath

The strand jack system relies on two collets on each strand, the upper collets being hydraulically lifted/lowered as a cable group. Additional hydraulics activate the collets under computer control, the timing of the collet activation determining whether the strands are raised or lowered. Each cable lifting system was to be supported by four pneumatic cylinders with 4m strokes and with a large nitrogen gas reservoir, the pressure being matched to the cable load so that large movements due to swell (within the cylinder stroke limits) would have minimal effect on the cable loads.

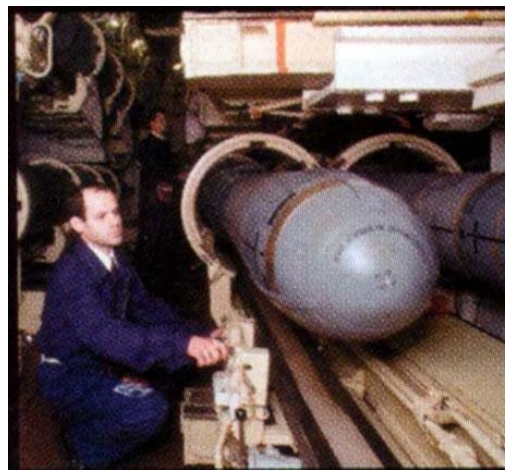
Port Torpedo Loading on Kursk

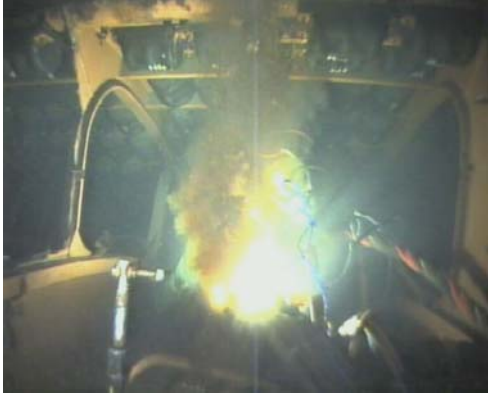
Saturation Diver Clearing Boat Services Located between Inner and Outer Hulls

The potential fault scenarios primarily related to cutting through the submarine ship's services occupying the cavity between the casing and pressure hull. Although engineering drawing details had been provided and location trials had been conducted on the sister boat *Orel* (K226), the as-built *Kursk* services installations were found to be markedly differ from the 'design' and/or from the actual installations on the *Orel*.

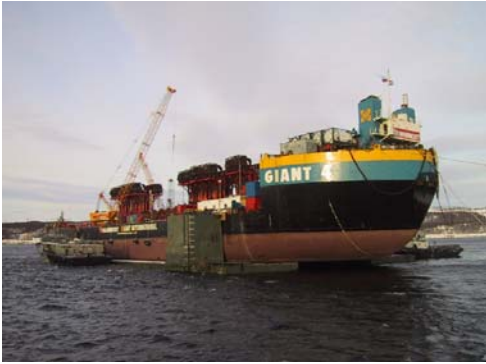
Giant 4 with the Kursk slung underneath awaits entry into the floating dock at Rosljakovo – two specially designed sinkable pontoons were deployed to raise Giant 4 for the necessary clearance into the floating dock

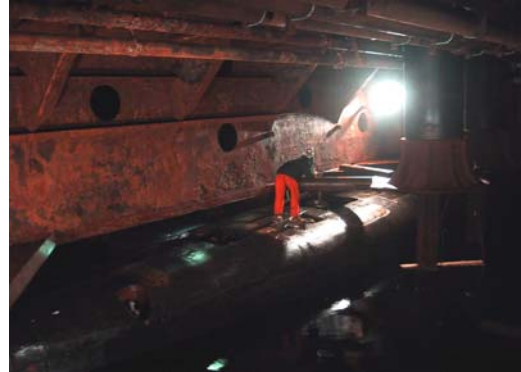
*Checking the Sail for Radioactivity
The sail (conning tower) of the Kursk protruding up into the cavity formed in the underside of the Giant 4*

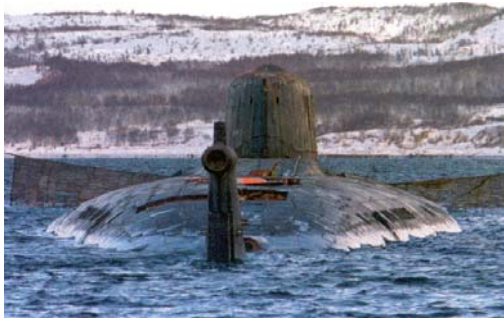
The Wreck of the Kursk Rising in the Well of the Floating Dock at Rosljako
